ANDERSEN

Service Kit for 68, 72ST
"Above Deck" Compact Motor™

*Instructions for Lip Seal
Replacement and
Gearbox Service*

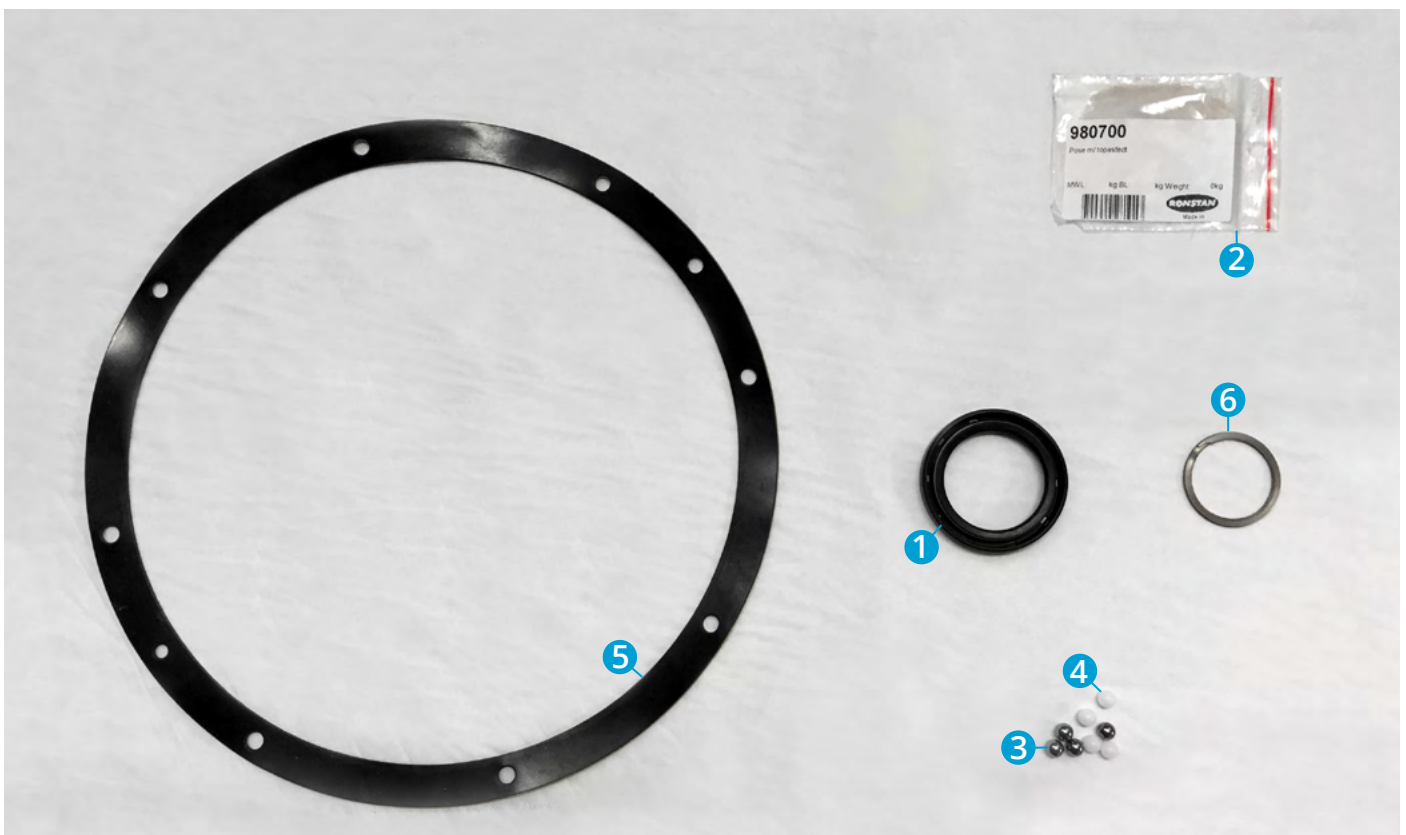
Service Kit Contents

Please take a moment to familiarise yourself with the contents of the RA710027 service kit.

- 1 RD100820 36mm x 50mm x 7mm Lip Seal
- 2 980700 Klüber Isoflex® TOPAS NB52 Grease
- 3 724900 Stainless steel ball bearings, 4 pcs
- 4 724902 Acetal ball bearings, 4 pcs.
- 5 822000 Gasket for 68-72ST
- 6 712800 Circlip

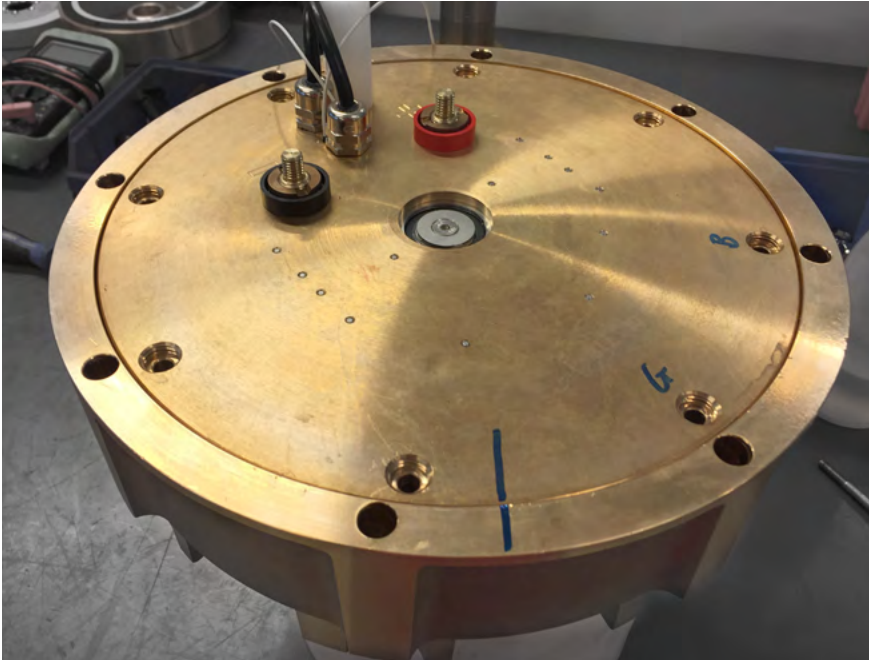
STEP 1

Before disassembling the motor/gearbox unit, turn upside-down and make a reference mark on the bottom as shown to facilitate re-assembly.

Mark across gearbox housing and motor base

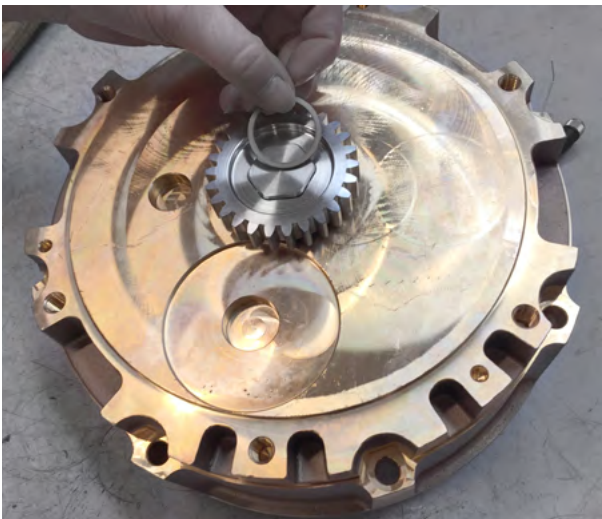
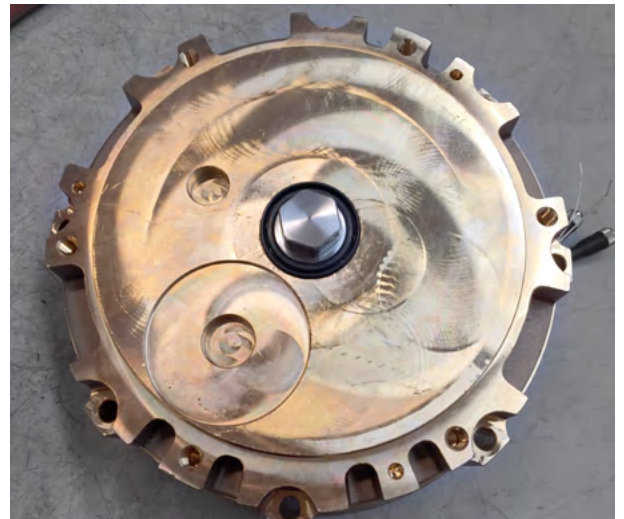
STEP 2

Remove the circlip as shown, then remove the drive gear from the output shaft. If the original circlip is damaged or lost, a replacement (part number 712800) is provided in the Service Kit for use during re-assembly.

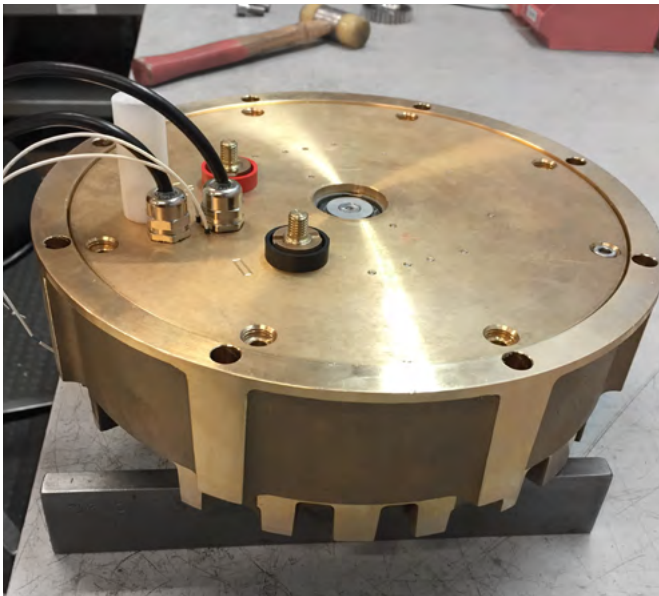
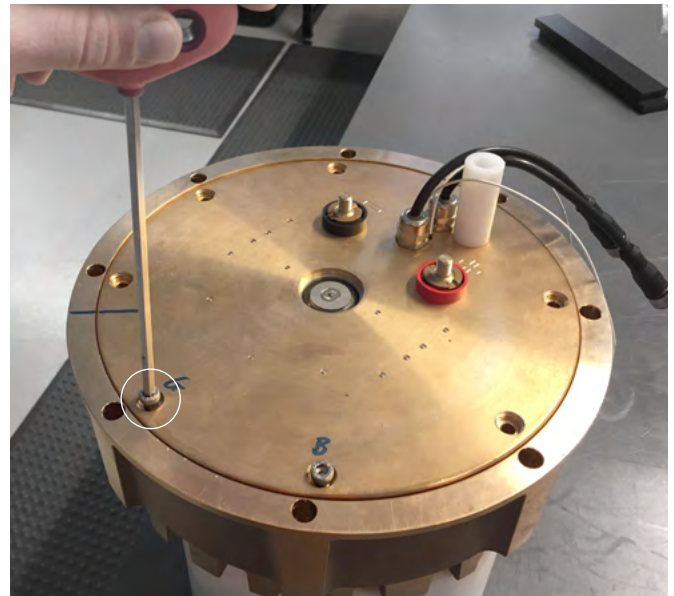
STEP 3

Turn the motor/gearbox unit upside down and place it on a pair of support blocks so that it is not resting on the drive gear. The support blocks should be 12mm wide x 40mm high x 250mm long – a pair may be ordered separately as part number 821811. Then remove the 8x M6 socket head screws that secure the motor in the gearbox housing.

Remove 8x M6 socket head screws

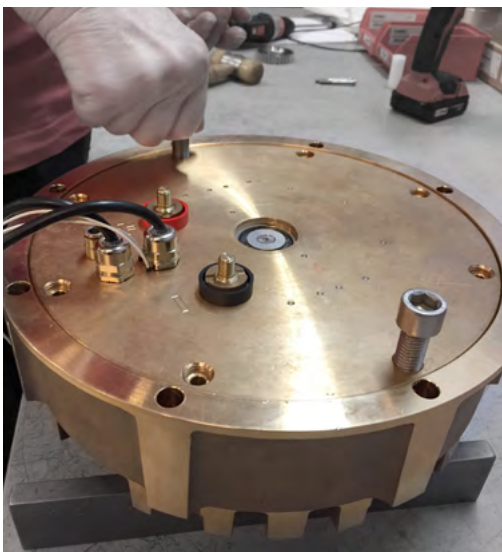
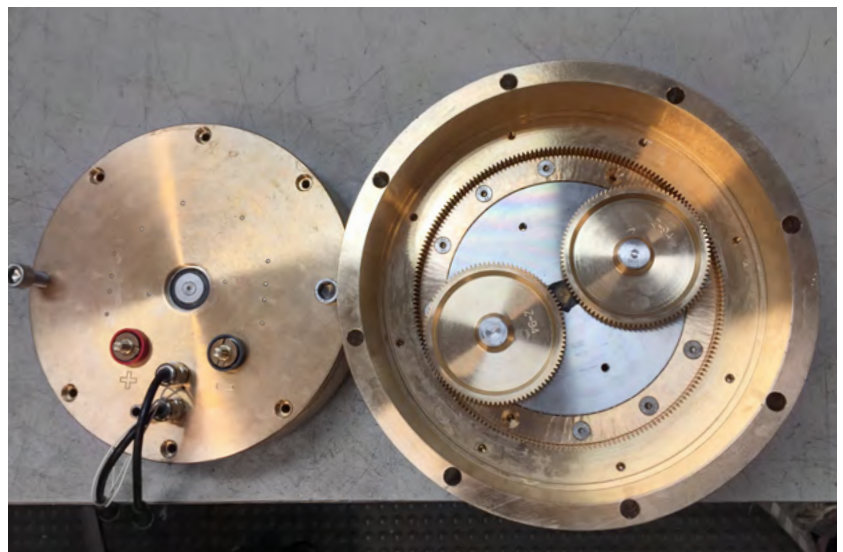
STEP 4

Insert any 2x M10 screws into the M10 threaded recesses, and use these as handles to lift the motor. If residual deck sealant or adhesive has penetrated between the motor and gearbox, help from a second person may be necessary to detach the two parts. Thoroughly remove any old sealant in order to achieve a clean re-assembly.

Insert 2x M10 screws to lift the motor

Motor removed from gearbox

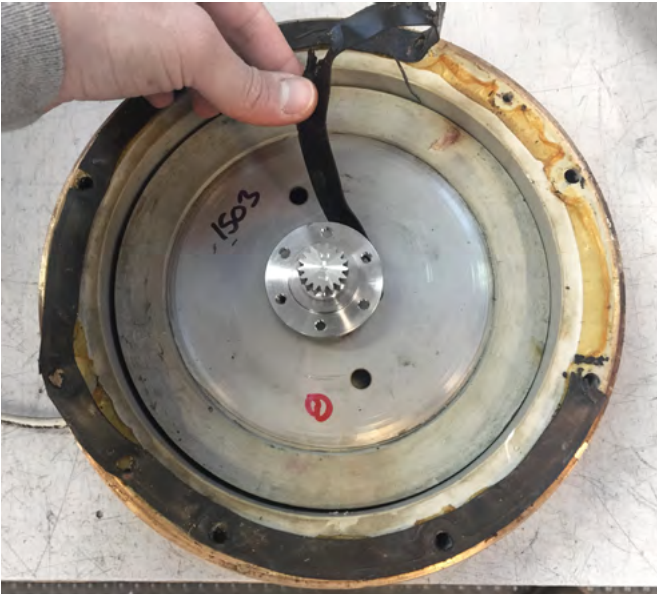
Motor Unit: Remove and discard the old gasket. Gently scrape away any remaining adhesive residue, taking care not to let any particles fall into the motor. Using a soft dry cloth or tack cloth, with no degreaser or spirits, remove any dirt or grease from the exposed inside surfaces of the motor unit. Take extreme care not to damage the teeth of the stainless steel planetary drive gear.

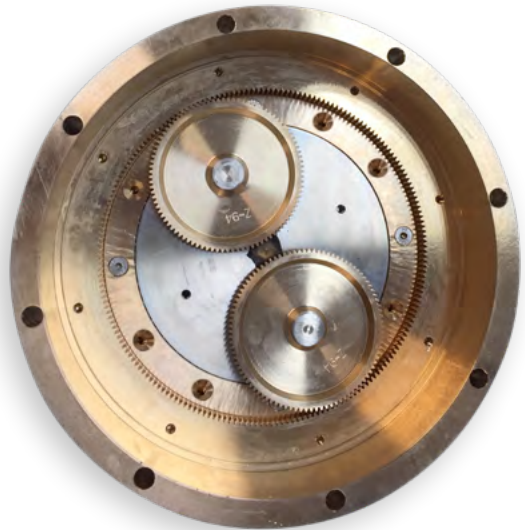
Gearbox: Wipe the inside of the gearbox and the planetary gears clean of dirt and grease using a soft cloth and a degreaser.

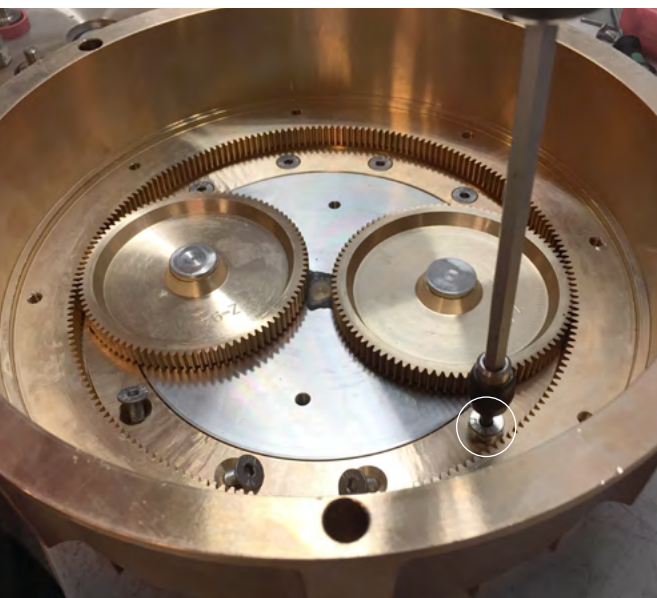
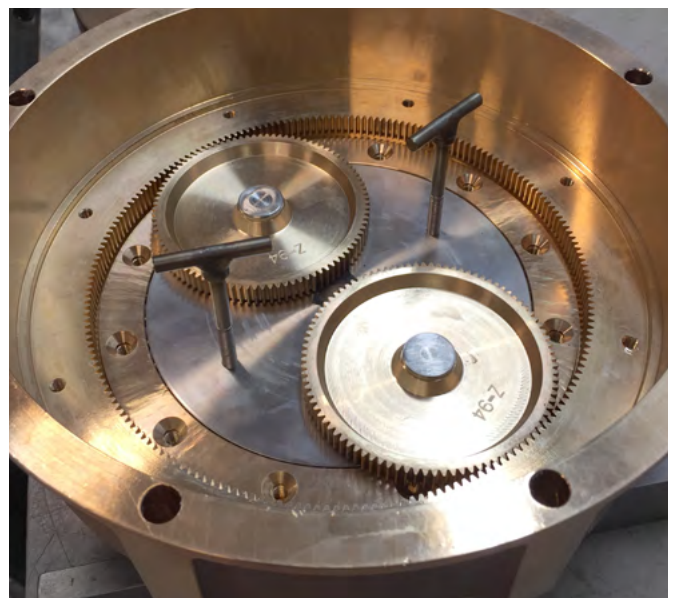
STEP 6

Remove the 12x M6 countersunk screws from the gear support. Place any 2x long M5 screws into the 2x M5 threaded holes provided on the stainless steel gear support, to use as handles for lifting this part.

Remove 12x M6 screws

Use any long M5 screws in the two holes provided

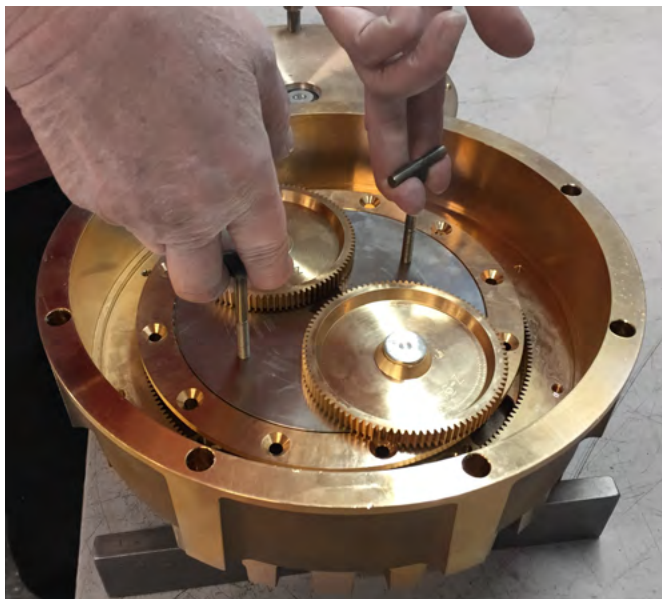
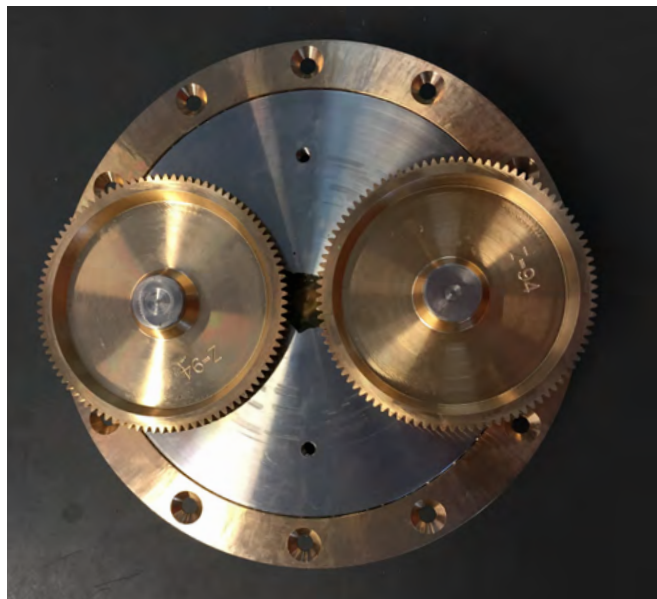
STEP 6 continued

Lift the gear support out of the gearbox housing, and place it on a flat surface (no support blocks necessary).

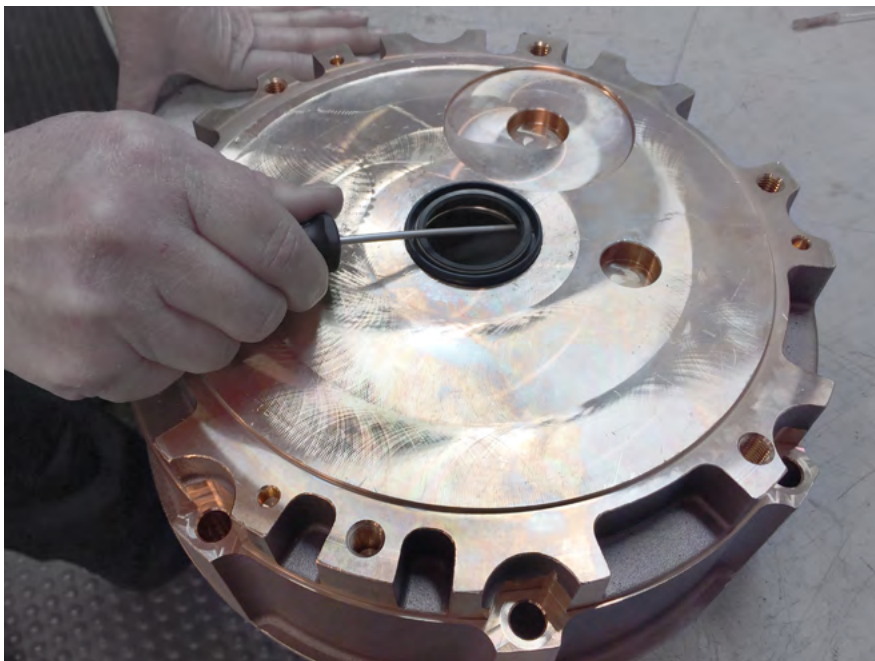
STEP 7

Turn the gear box upside down and remove the old lip seal by prying it out with the help of a screwdriver, taking care not to scratch or gouge the metal surface around it. The seal will be damaged/destroyed during this operation and can not be re-used.

Remove old lip seal using a flat screwdriver

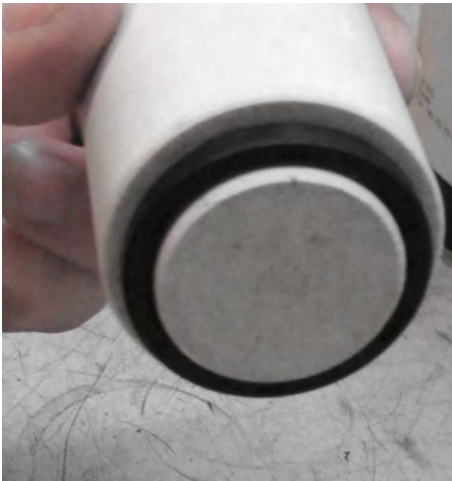
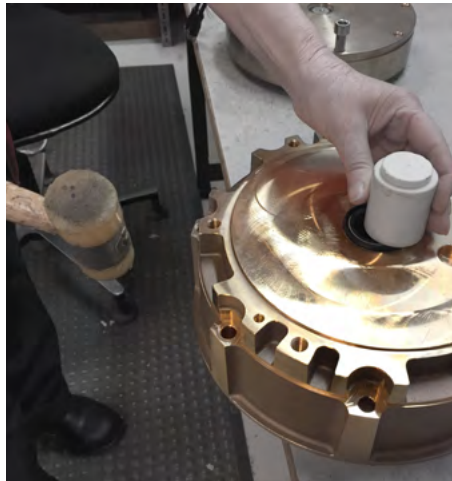
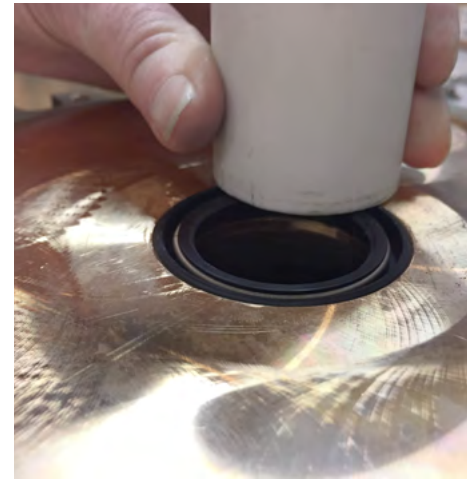
STEP 8

Locate the new lip seal, part number RD100820 (provided in the Service Kit). With its open groove facing up, align it accurately and gently press it completely into the recess in the gearbox so that it remains perfectly flush with the external surface of the gearbox. Do not use any grease during this step.

The optional mounting tool, part number 821810, can be used to help fit the seal.

1. Check which end of the tool has the correct diameter to fit your lip seal. Place the new lip seal, with its open groove facing up, onto that end of the tool.
2. Use the tool to insert the seal into the recess. The end of the tool will fit in the hole, accurately aligning the seal as it is inserted.
3. Tap with the help of a soft hammer to fit the seal perfectly and completely into position, flush with the external surface of the gearbox.
4. The seal must be perfectly flush with the cover plate, otherwise the drive gear and attached planetary gears will not engage properly when re-assembled.

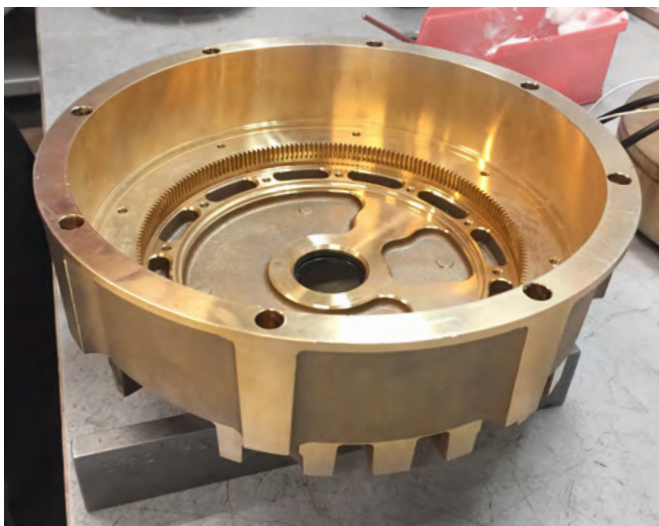
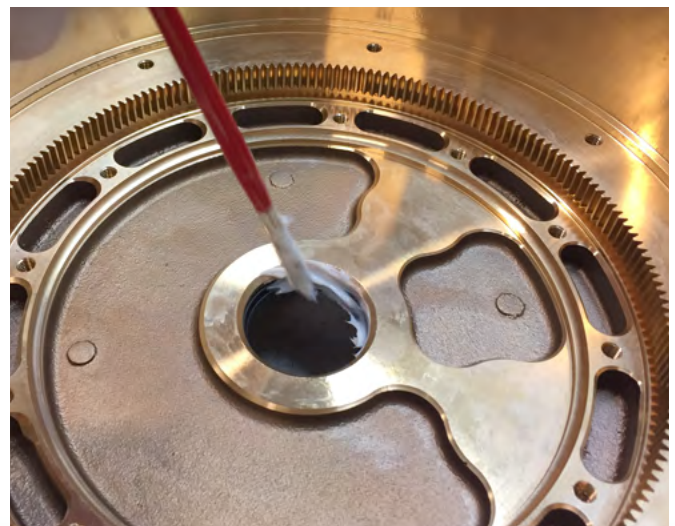
STEP 9

Turn the gearbox housing upside down again and place it on the support blocks. Locate the TOPAS NB52 grease, part number 980700 (provided in the Service Kit). Apply liberally to the lip seal, the adjacent internal surface, the ball race and the base of the drive gear.

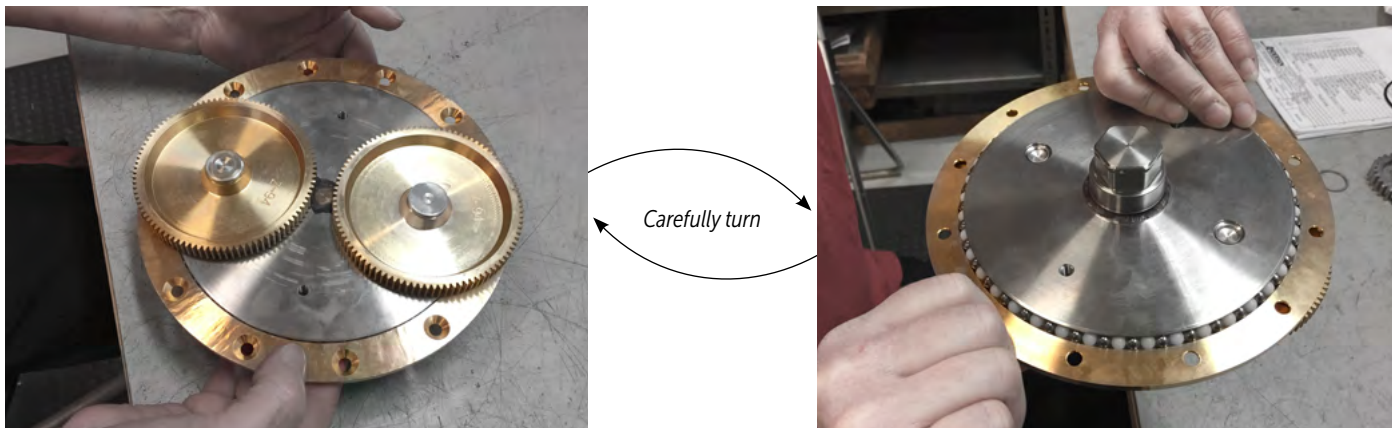
STEP 10

If the ball bearings appear dirty, proceed with removal and cleaning. To avoid losing any balls, this is best done over a box or a bucket. Remove the M5 screws that you used to lift the planetary gear support in STEP 6. Hold the stainless steel disc and the bronze ring firmly together, and turn upside down.

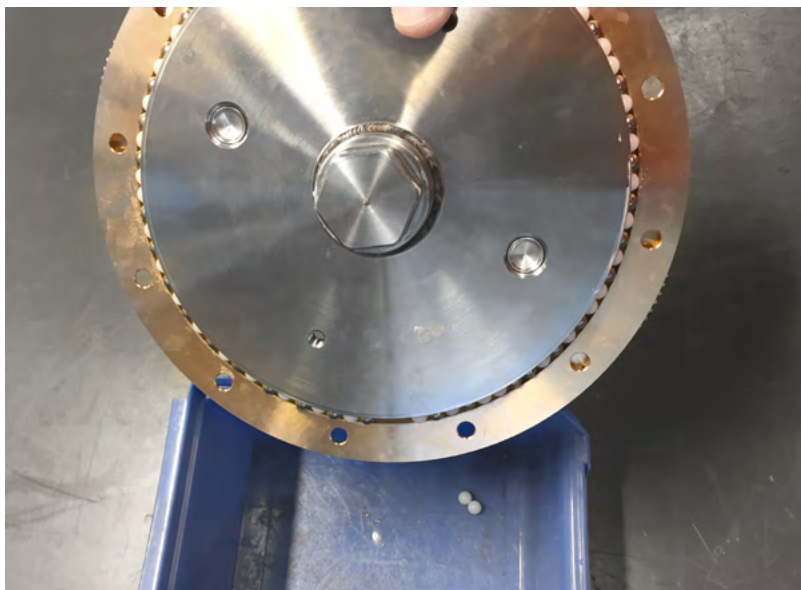
While positioned over the box and holding the stainless disc, gently separate the bronze ring and carefully remove the balls. Help with fingers if they stick within the ball race. There are 41 stainless steel balls and 42 acetal balls.

Carefully remove the balls over a box or a bucket

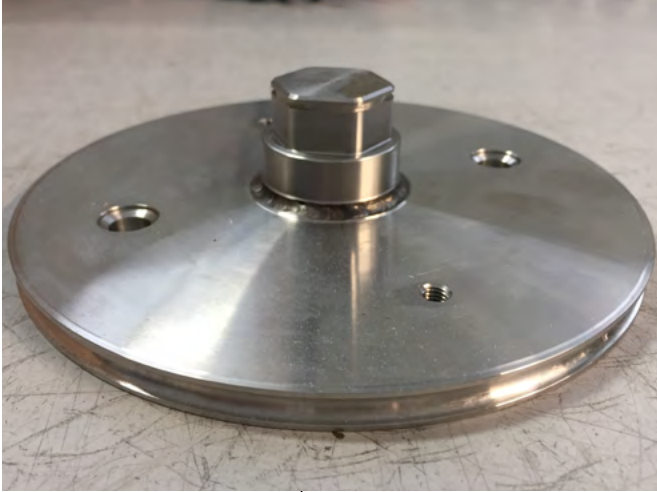
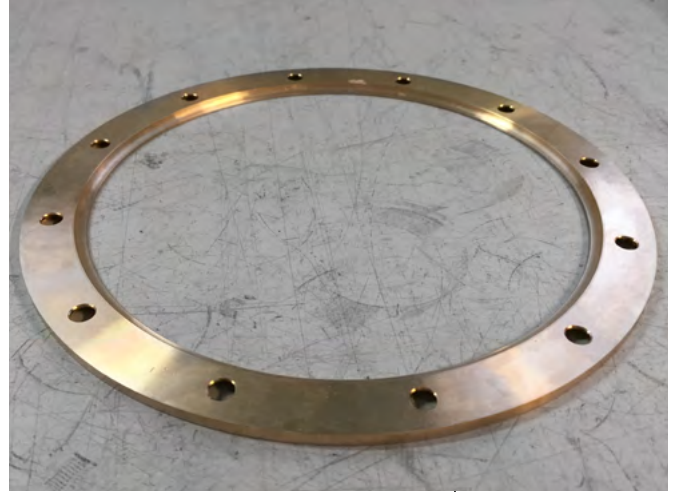
STEP 11

Remove the bronze ring. Clean and degrease the ball bearings, the ball races in the stainless drive unit and the bronze ring.

Stainless drive unit ball race

Bronze ring ball race

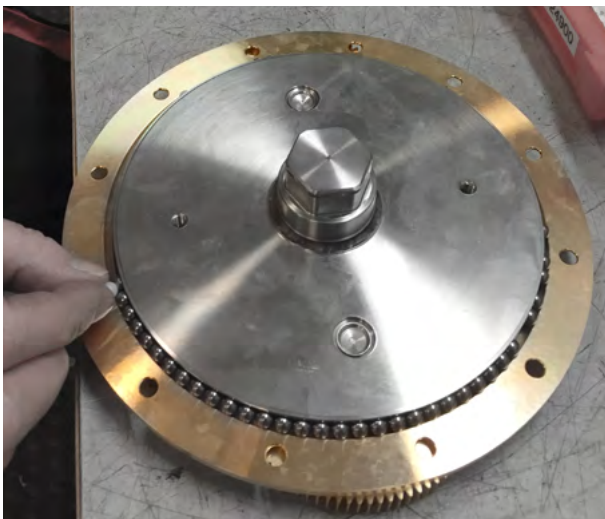
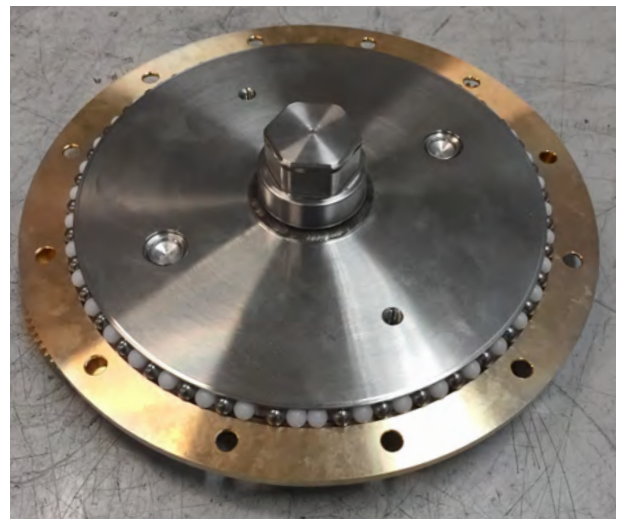
STEP 12

Place the stainless disc on a flat surface, then place the bronze ring in position from above. The gap between them will be just sufficient to insert the balls. There are 41 stainless steel balls and 42 acetal balls – four spares of each are provided in the Service Kit.

Place the stainless steel balls in the ball race, then insert the white acetal balls between them so the stainless balls do not touch each other. The last acetal ball will sit next to another acetal ball as indicated below. For best results be patient and go slowly, placing the balls gently into position.

The last acetal ball will sit next to another acetal ball

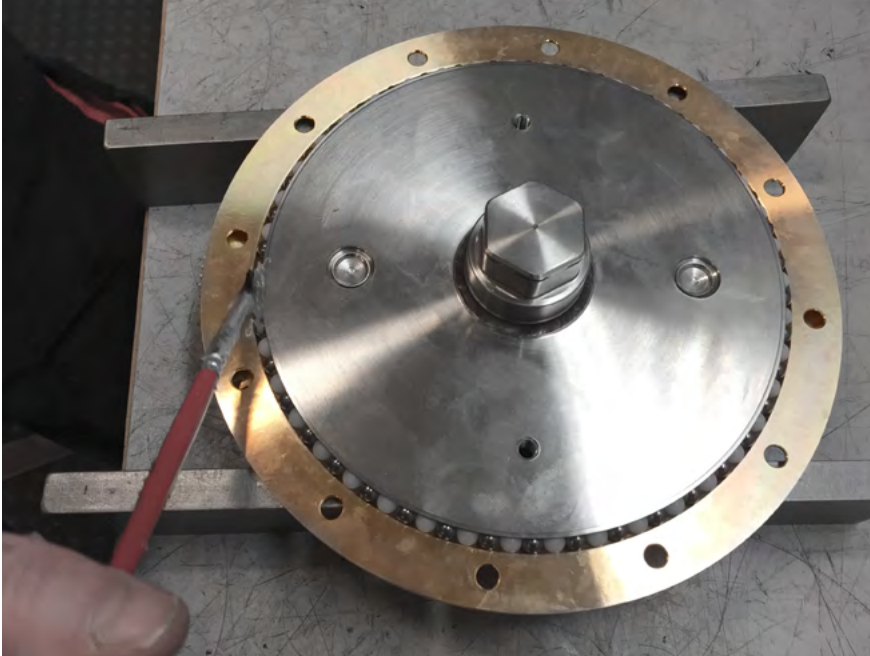
STEP 13

Holding it by the bronze ring, lift the gear assembly and place it on the two support blocks. Using a small brush, apply Andersen Winch Grease to the ball bearings.

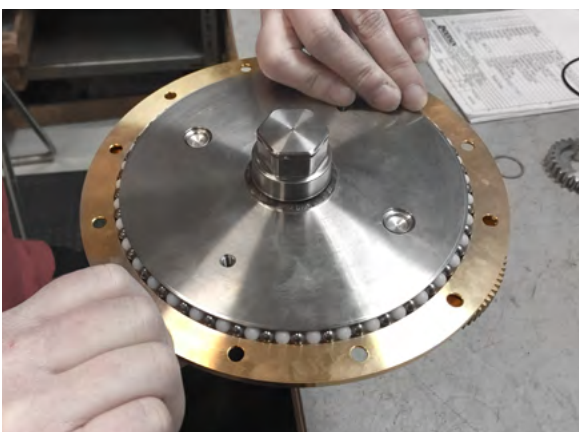
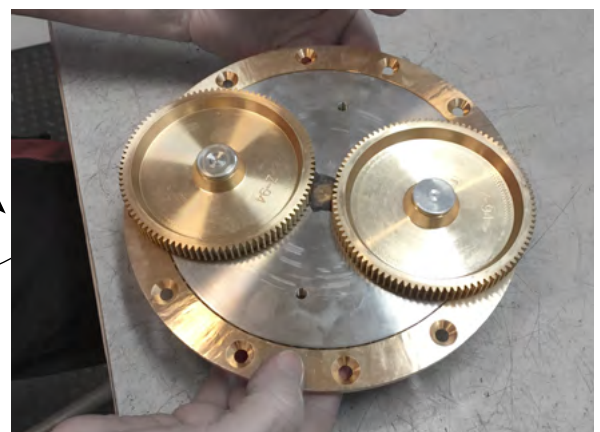
STEP 14

1. Hold the bronze ring pressed against the stainless steel gear support disc to prevent the balls from dropping out, and turn it upside down.

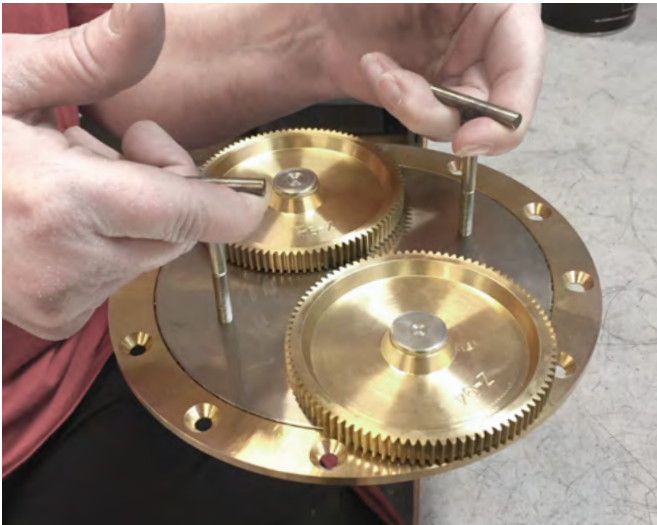
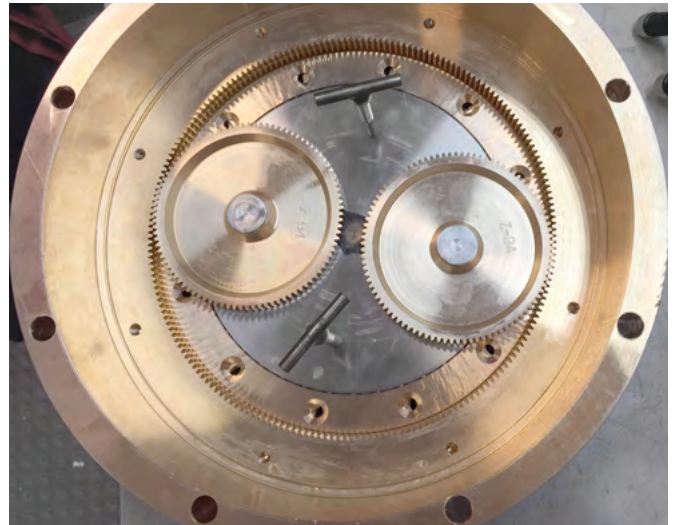
STEP 14 continued

2. Hold the gear support again with the help of your 2x M5 screws, and place it back into the gearbox housing.

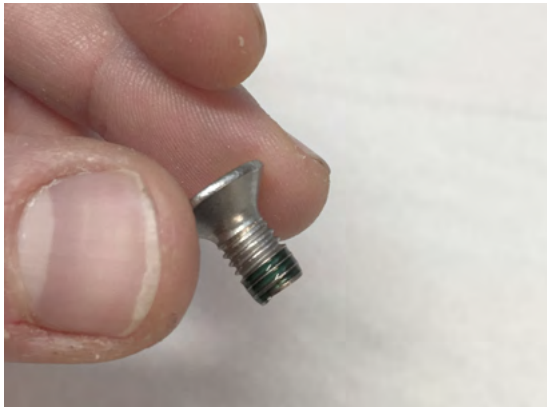
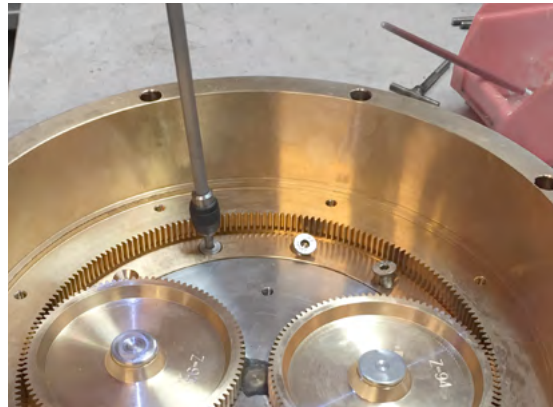
3. Align the countersunk holes in the bronze ring, then insert and tighten the 12x M6 countersunk head screws. Use a drop of threadlock, medium strength, on each screw.

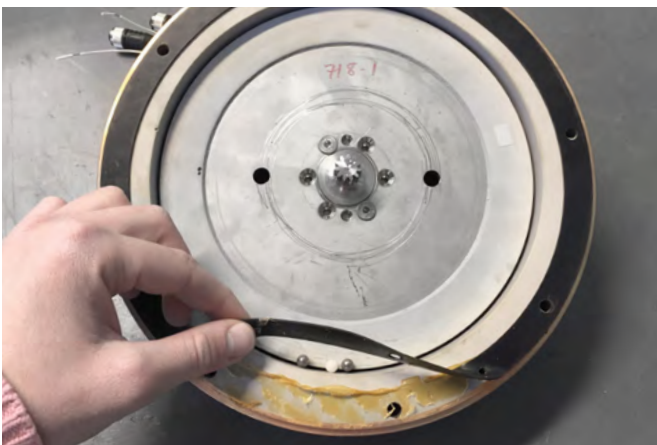
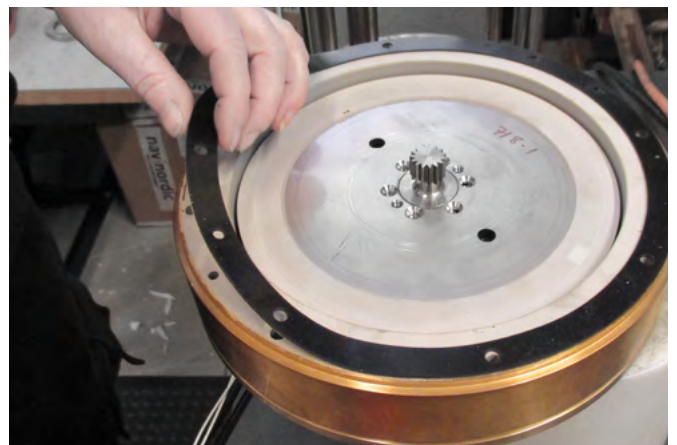
STEP 15

Locate the new gasket, part number 822000 (provided with the Service Kit). Ensure that the mounting surface is clean and free of any residue from the old gasket. Place the new gasket in position with the adhesive side down, taking care to align the hole locations before peeling off the backing paper from the adhesive side.

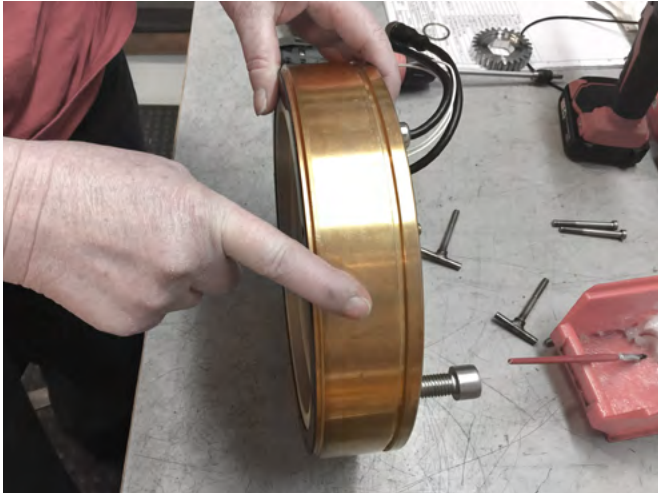
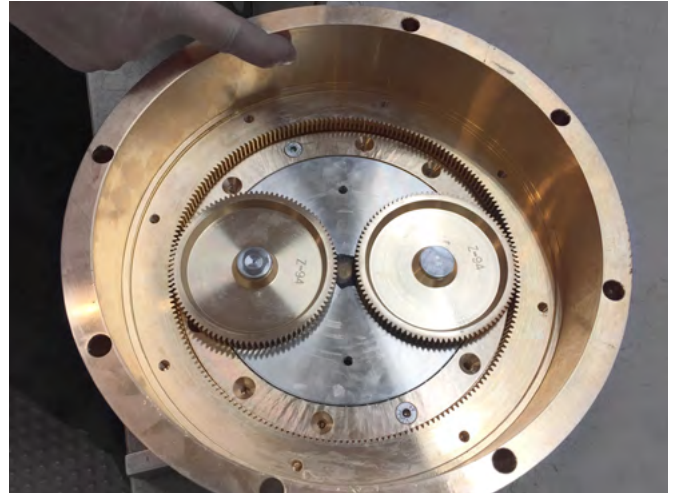
STEP 16

Make sure that the external surface of the motor and the internal surface of the gearbox are clean, to ensure perfect fit and alignment when re-assembled.

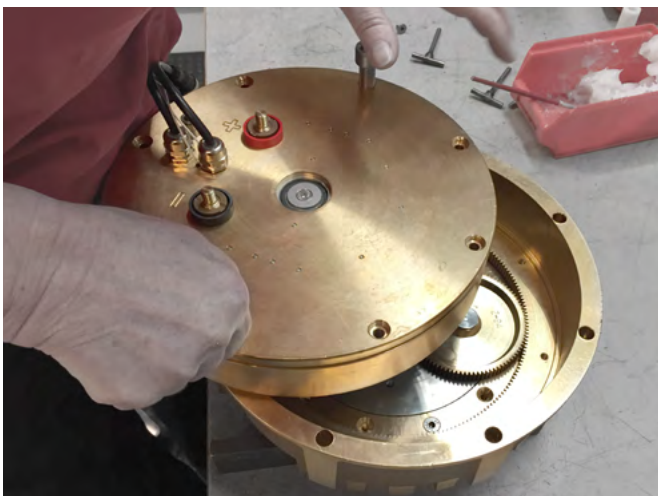
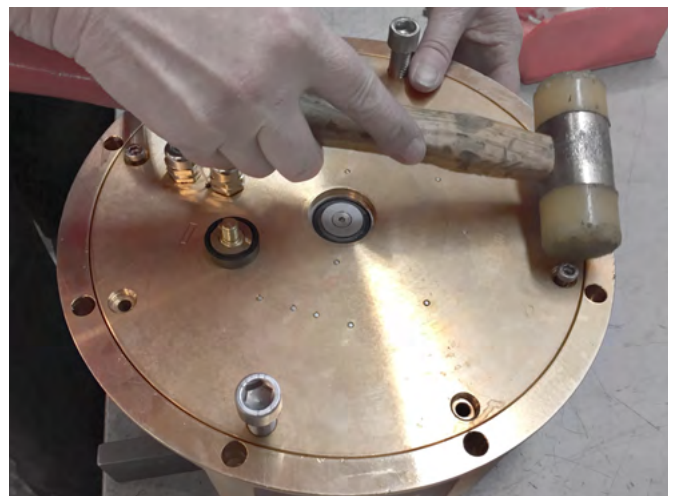
Again as in STEP 4, use your 2x M10 screws as handles to lift the motor. Lower the motor into the gearbox, using your original alignment mark as a positioning reference. You may need to gently rock the assembly to allow the planetary gears to engage as the motor drops into position. Take care to align the holes for the 8x M6 socket head screws that will hold the assembly together. To aid with correct positioning, you may partially insert one of the screws and tap very gently with the soft hammer to rotate the motor slightly within the gearbox housing.

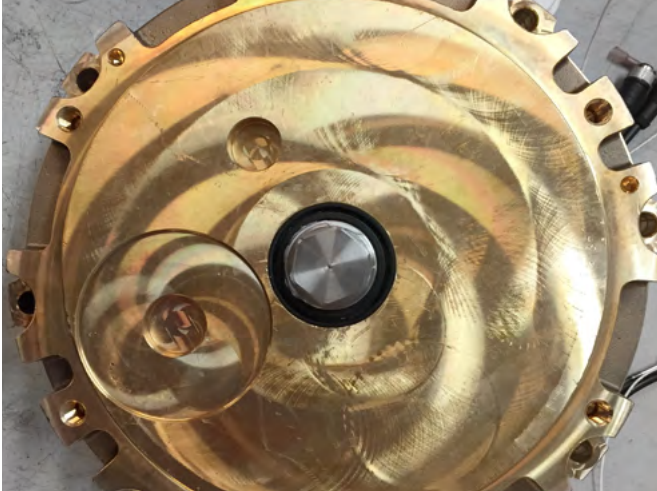
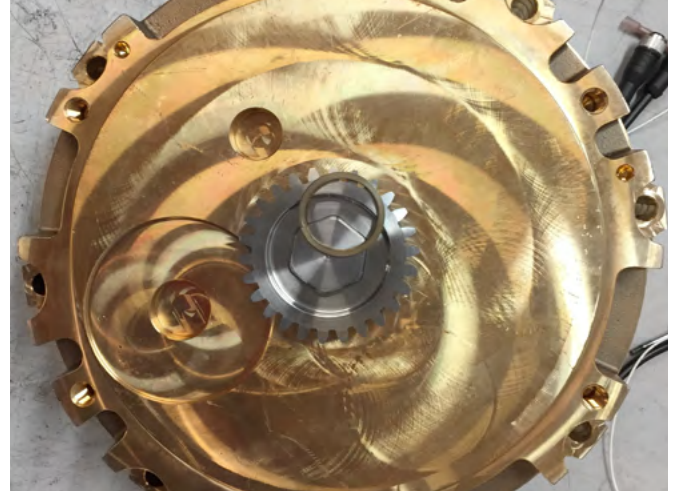
STEP 17

Turn over the motor/gearbox assembly so the output shaft is facing up. Place the drive gear back in position on the output shaft and secure it with the circlip.
